Job No: 62045
VL
5th October 2018

Review of Waikaraka Park Grandstand

Photo record taken on 10th September 2018

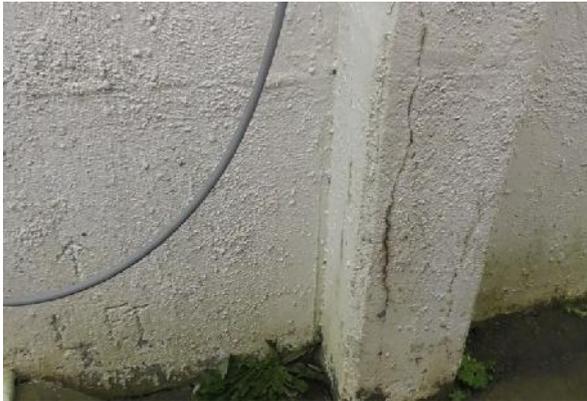
Fig 6: Northern column of the western wall

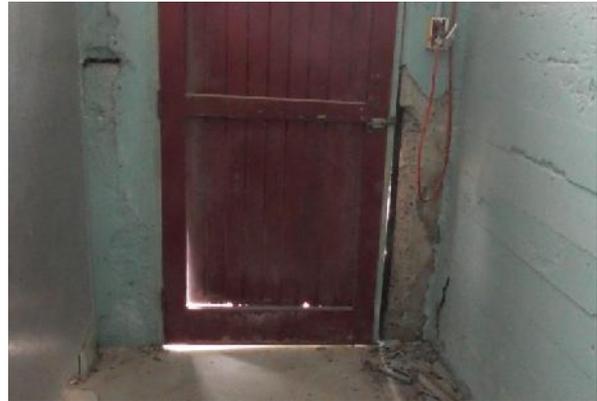
Fig7: Inside view of the Western wall

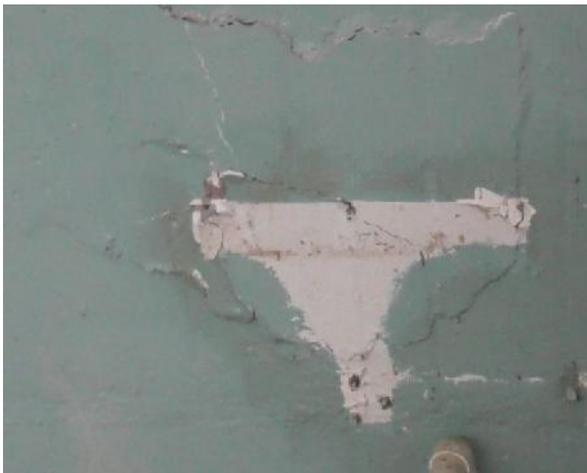
Fig. 8: Typical inside view of Western wall damage

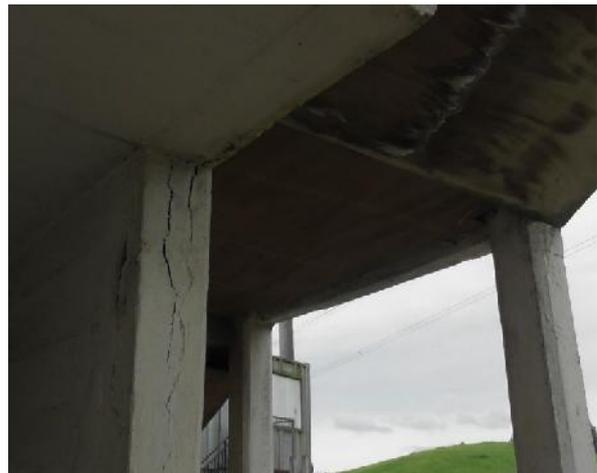
Fig 9: Northern end wall tension crack

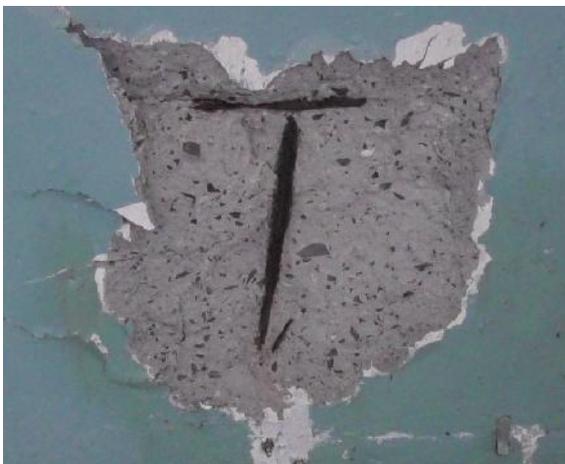
Fi.10: Wall damage shown in Fig. 8

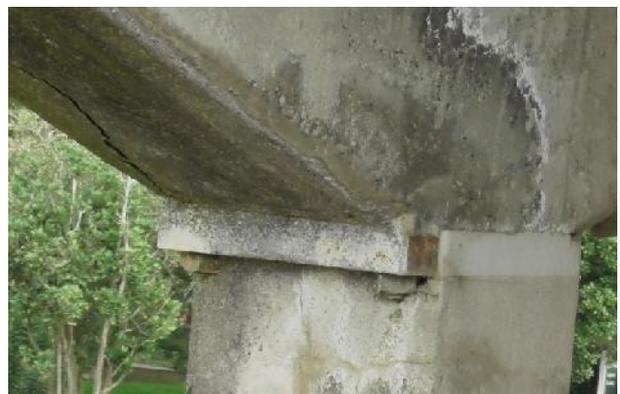
Fig 11: Upper deck beam crack

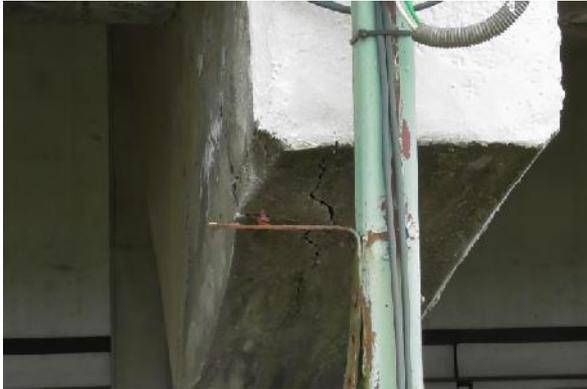
Fig 12: Upper deck beam crack

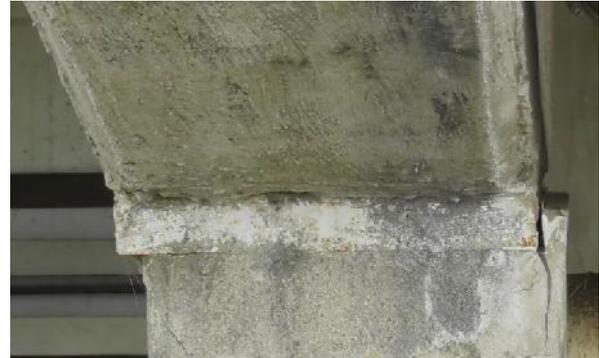
Fig 13: Upper deck beam column joint

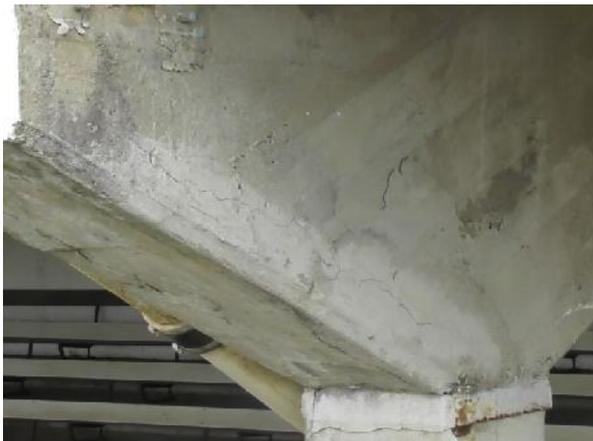
Fig 14: Upper deck beam surface tension crack

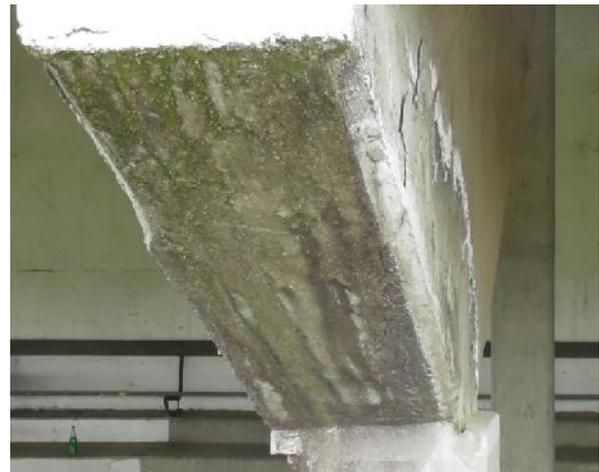
Fig 15: Upper deck beam surface tension crack

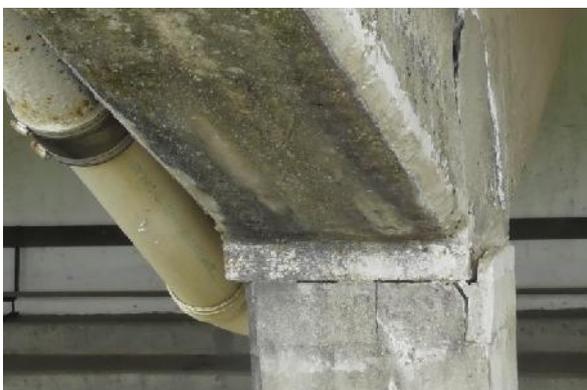
Fig 16: Upper deck beam and post deterioration

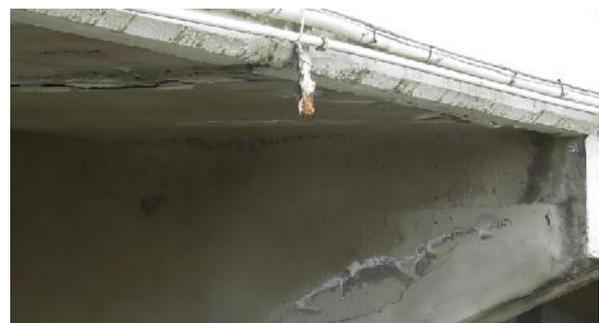
Fig 17: Upper deck beam surface tension crack

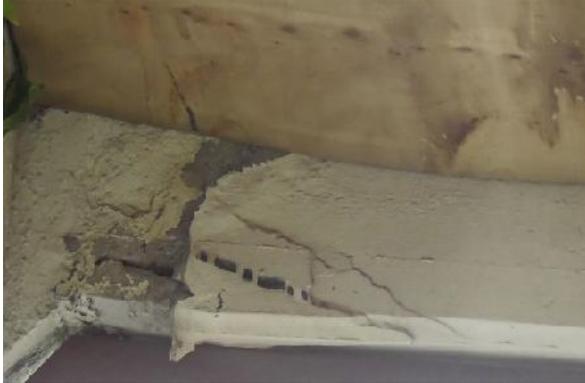
Fig 18: Upper deck ramp beam damage

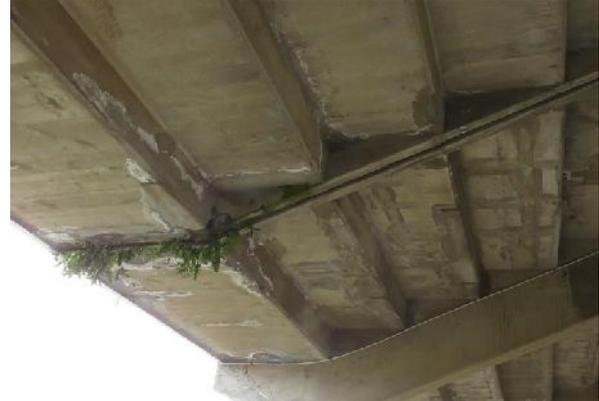
Fig 19: Upper deck slab damage

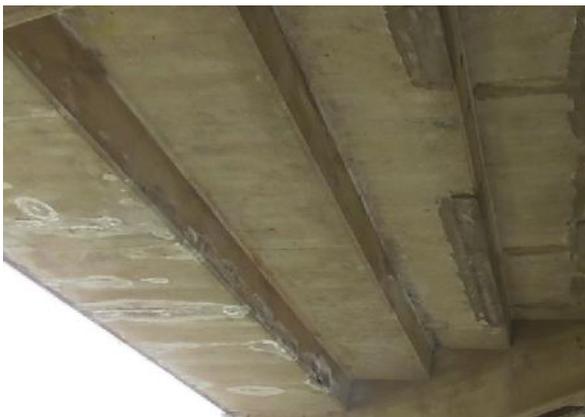
Fig 20: Upper deck slab damage

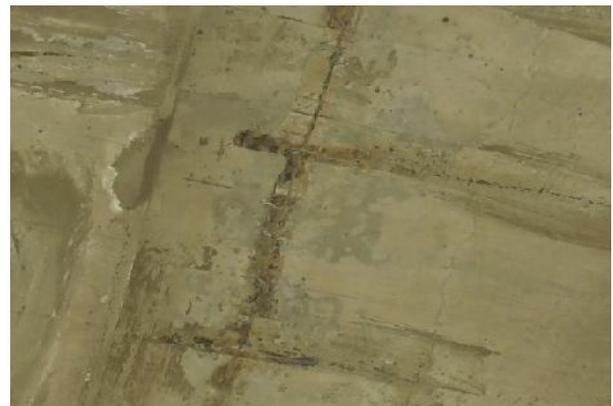
Fig 21: Upper deck slab damage

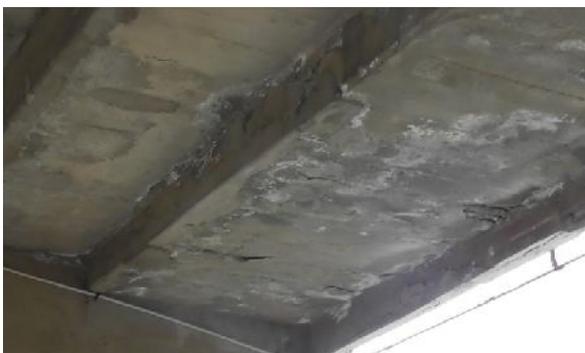
Fig 22: Upper deck slab damage

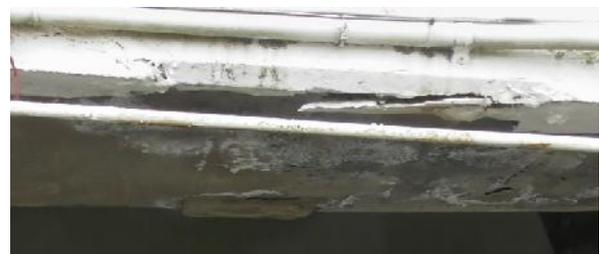
Fig 23: Upper deck balustrade bottom edge

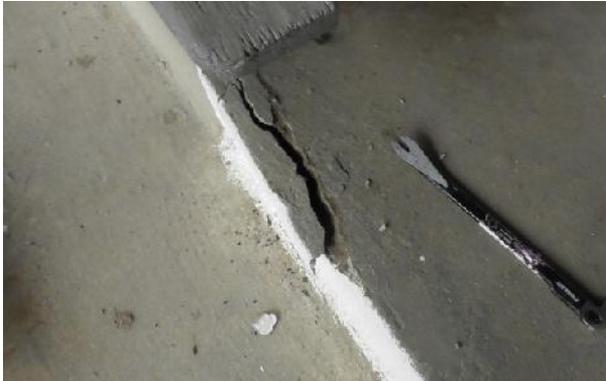
Fig 24: Lower deck slab tension crack

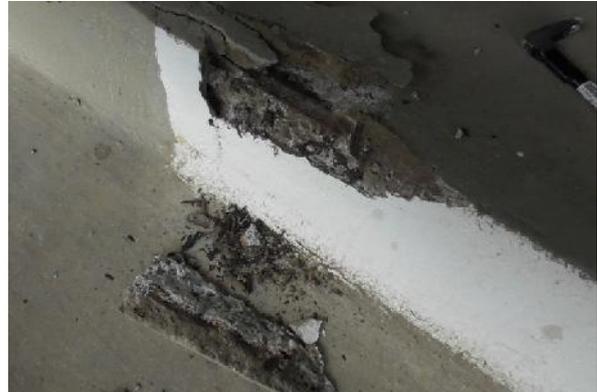
Fig 25: Damage shown in Fig 22

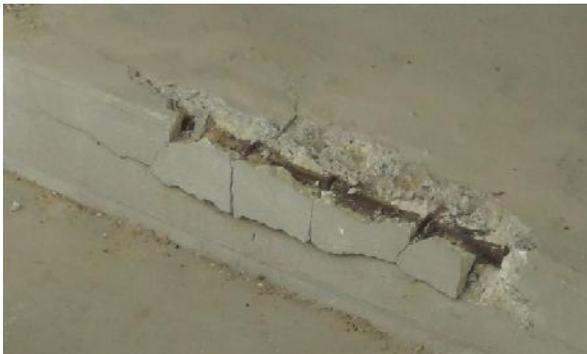
Fig. 26: Lower deck slab damage

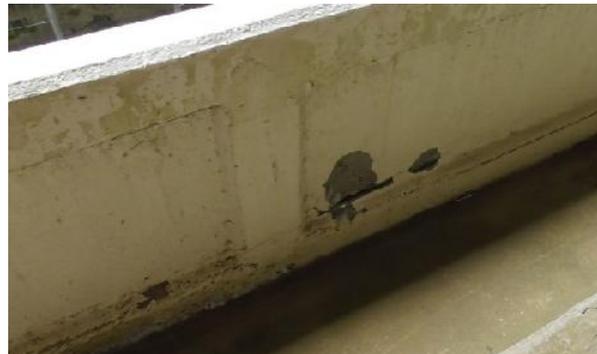
Fig 27: Lower deck balustrade corrosion

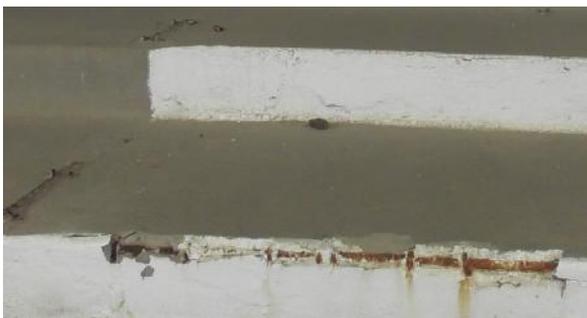
Fig. 28: Lower deck slab damage

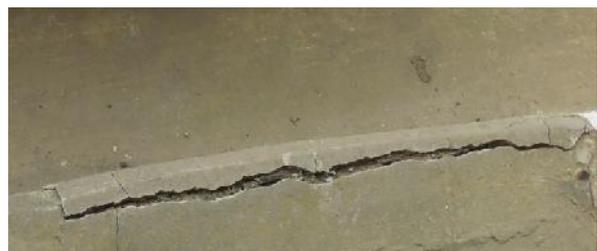
Fig 29: Lower deck slab damage
