**Attachment B**

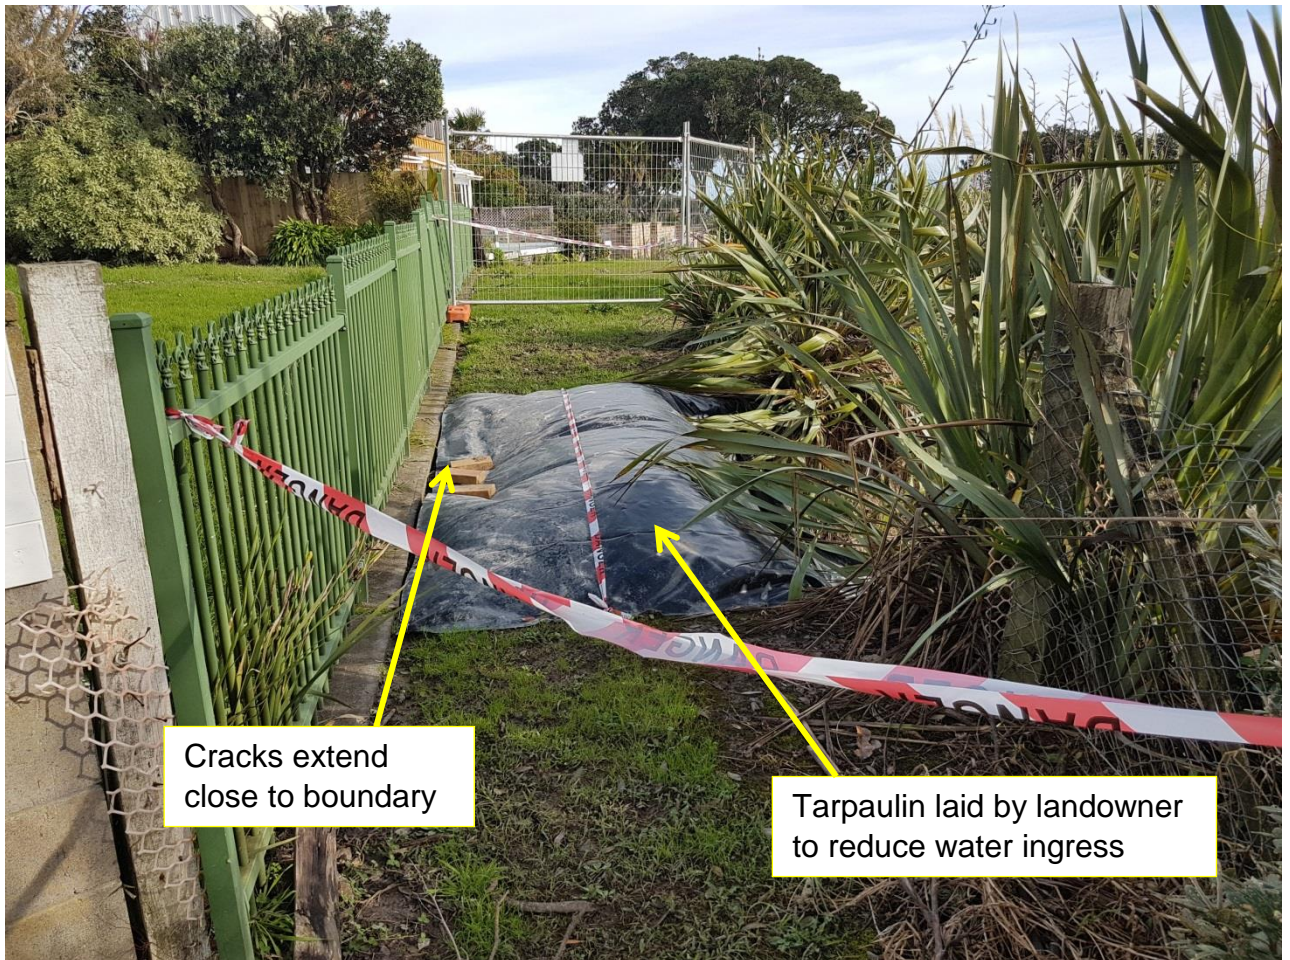
Cracks extend close to boundary

Tarpaulin laid by landowner to reduce water ingress

**Figure 2: Photograph of landslide crest, looking west. Private property at 3 Pohutukawa Road on the left of the image.**
