# Storm damage remedial track updates for Le Roys Bush Reserve and Leigh Reserve

Kaipātiki Local Board – 7 May 2025 Workshop

# Le Roys Slip's Aerial Slide

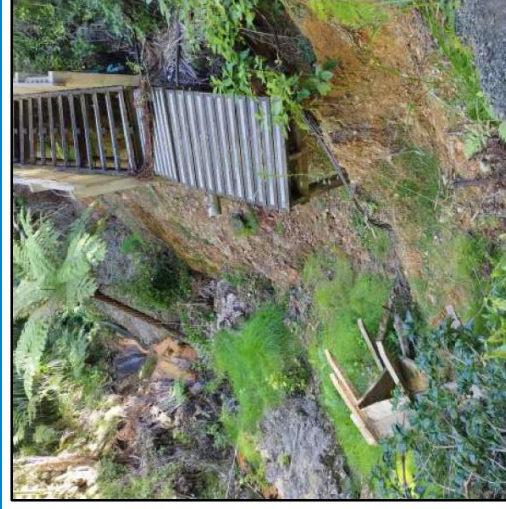
## Le Roys Slip 2 – detailed design (ready for consent)

- Install 10.9m long x 1.2m wide boardwalk.
- Reposition existing 7.5 long by 2m wide staircase up side of historic slip.
- Install 4.5m long by 1.2m wide timber bridge.
- Install 1.6m long by 1.2m wide timber staircase.
- Install 1.2m wide aggregate track.
- Consenting is underway for SLIPS 2-4.
- Savings can be achieved if SLIPs 2-4 are completed at the same time to save on separate P&G costs for each slip.

(Right Photo: shows the exposed pipe and the undermined pathway. Left Photo: shows the extent of the scouring downslope of a bridge. Date Taken: 15/01/2024)

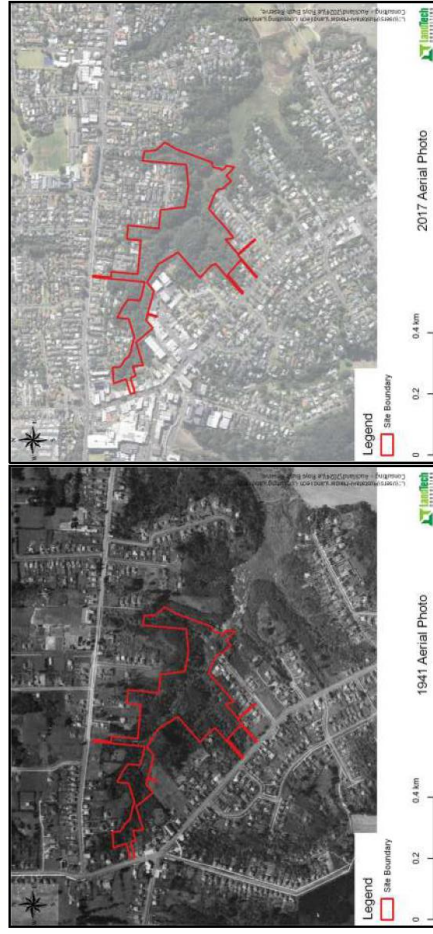
Figure 3: Left Photo - 1961 Aerial Photo Right Photo – 2017 Aerial Photo

(Source: [retrolens](#), accessed on 13/02/2024)

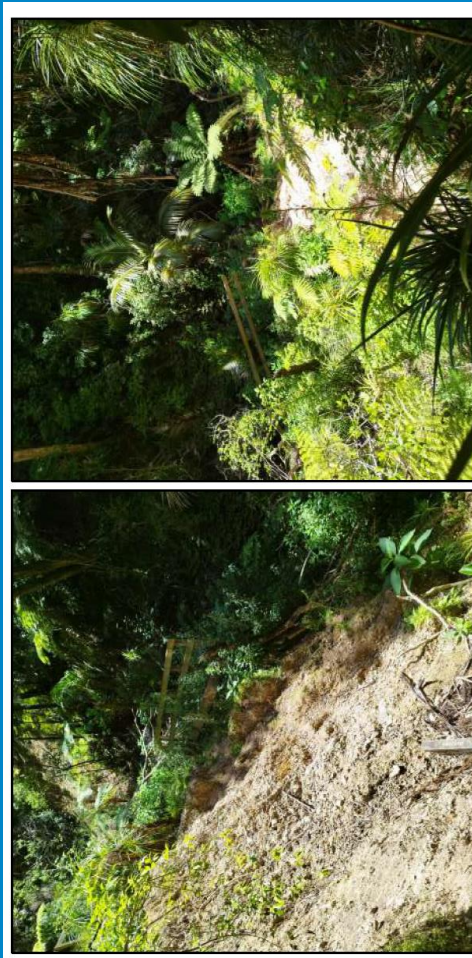
## Le Roys Slip 4 – detailed design

- Decommission existing track.
- Remove boxed steps.
- Install warning signs.
- Decommissioned existing track.
- Install barrier with warning signs.
- Existing boardwalk to be repaired and barrier to be reinstated.
- Proposed new and existing aggregate tracks.
- Proposed new boxed steps to existing track.
- Consenting is underway for SLIPS 2-4.
- Savings can be achieved if SLIPs 2-4 are completed at the same time .

(Right Photo: shows at the slip at the base. Left Photo: shows the slip looking down from the upper portions of the slope. Date Taken: 15/01/2024)
