## ***Safer Waters, Stronger Communities: Local Solutions to Prevent Drowning***

## Gap Analysis

### Environmental Design and Drowning Prevention

Client: Drowning Prevention Aotearoa

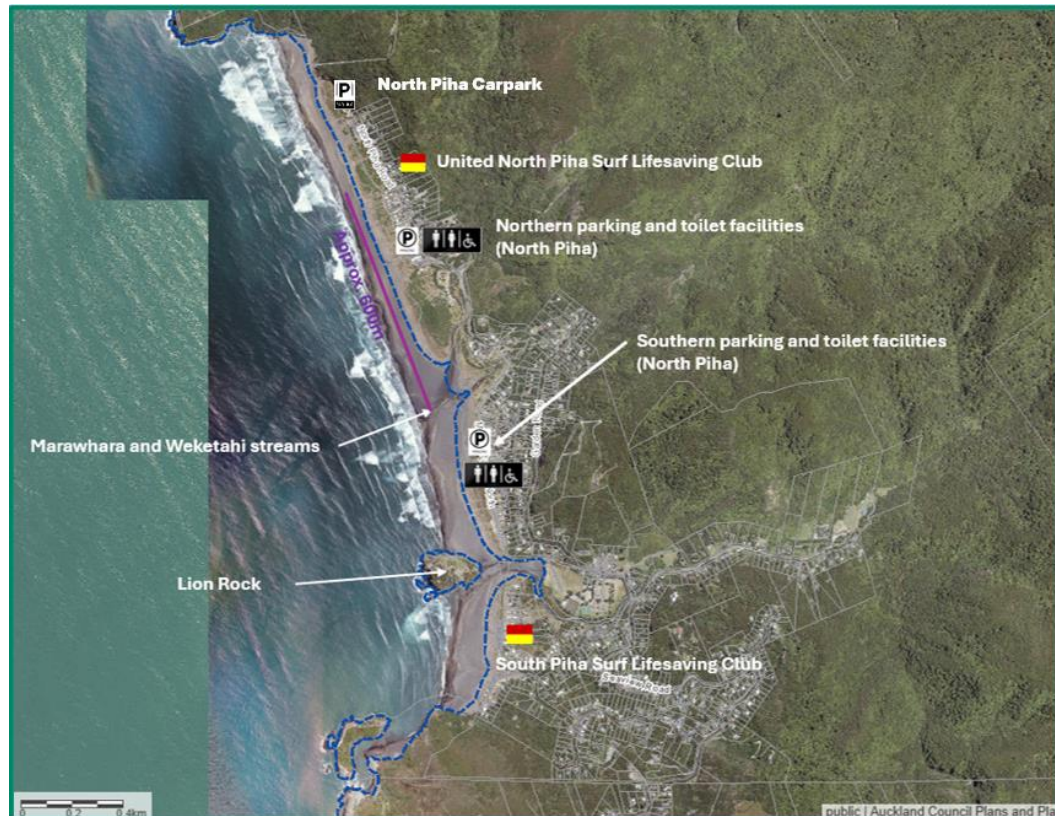
Figure 1: Map showing key characteristics and facilities at Piha Beach

Piha Beach is a popular surf beach on the west coast of Auckland. It is accessible by road and is less than an hour's drive from the Auckland Central Business District (CBD). North Piha Beach is separated from Piha Beach by Lion Rock. There is a river mouth at the southern end of North Piha Beach where two streams (the Marawhara and Weketahi streams) flow out to sea (as shown in Figure 1). There is a permanent rip at this location (at the outflow of the Marawhara and Weketahi Streams) where the men were swimming. The river mouth, at the southern end of North Piha, cannot be seen by the lifeguards at Piha Beach because Lion Rock obstructs the view. The river mouth is within the view of the lifeguards at North Piha; however, it is a significant distance (about 600 metres) away from the lifeguard tower and from where the patrolled flag area is usually set up. The river mouth area is however directly in front of public changing rooms and toilets and a carpark, where the group got changed in the changing rooms and went down to the beach directly in front of there.

The location of the public changing and toilet facilities raises concerns. The two men and their friends, like many visitors, parked in the carpark and used the public changing facilities before heading directly to the beach. These facilities are located at the south end of the beach, just past Lion Rock, near where the two streams flow into the sea. As described above, this area is particularly hazardous. However, it is the first set of public facilities visitors encounter at North Piha Beach. It is unclear why these facilities were built in this location. Dr Kearney agreed with concerns and advised that the placement of the toilets and other public amenities directly influences beach usage patterns. He advised that, when planning coastal developments such as beach accessways, coastal walkways, car parks, playgrounds, and toilets, consultation with SLSNZ or other water safety organisations could prevent numerous instances of amenities being positioned in dangerous spots. He noted that the lack of consultation with Surf Life Saving, and other water safety organisations has led to the inappropriate placement of facilities that not only endanger beachgoers but also complicates the work of Surf Life Saving by altering beach usage patterns.

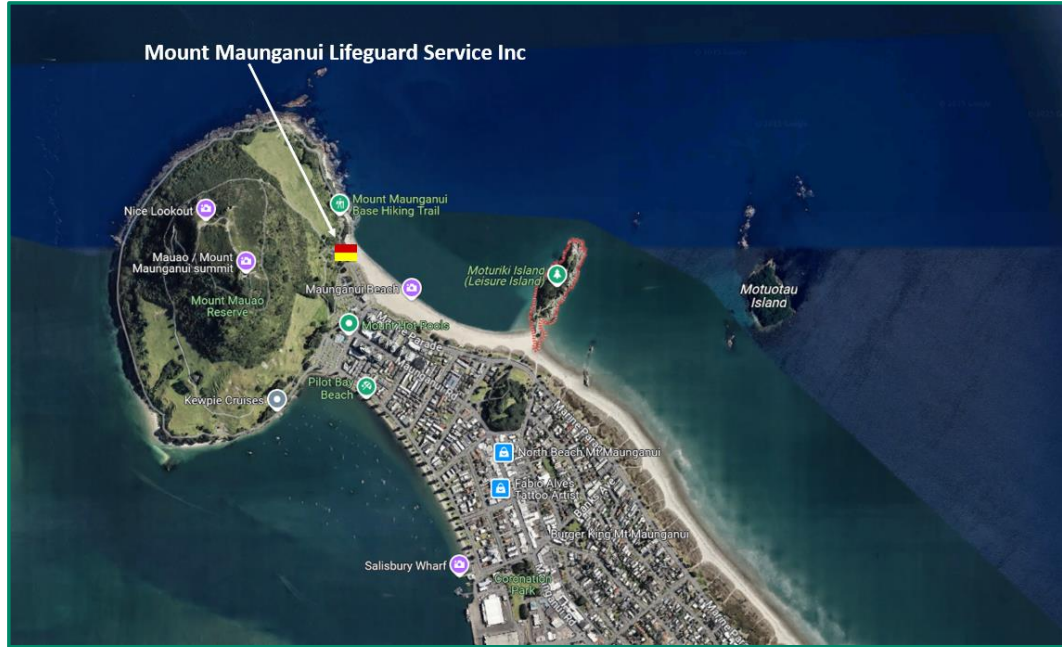
Figure 2: Mount Maunganui environmental features including the surf lifesaving club and Moturiki Island (Leisure Island)

A coronial report<sup>3</sup> finds that a man died on 12 November 2022 of accidental drowning. The incident leading to his death occurred at Moturiki Island, Mount Maunganui. Figure 2 shows Moturiki Island (Leisure Island) in relation to Mount Maunganui Lifeguard Service Inc.

The coronial report also finds that, within the Mount Maunganui Beach and Moturiki Island coastal zone, there was no water safety signs that adhere to Standard 2416:2010. The standard advises that water safety signs should comply with the relevant international standards, which outline graphical symbols for accident prevention and health hazard information. Supplementary text should accompany the symbols to explain their meaning, directly relating to the sign. Standard 2416:2010 states that the selection and use of signs should be based on a risk assessment, considering factors such as hazards, associated risks, and the likely behaviour of users in the aquatic environment.
