BUILT HERITAGE SPECIALIST MEMO

Subject: R/LUC/2016/3407 – 7 Arthur Street, Freemans Bay

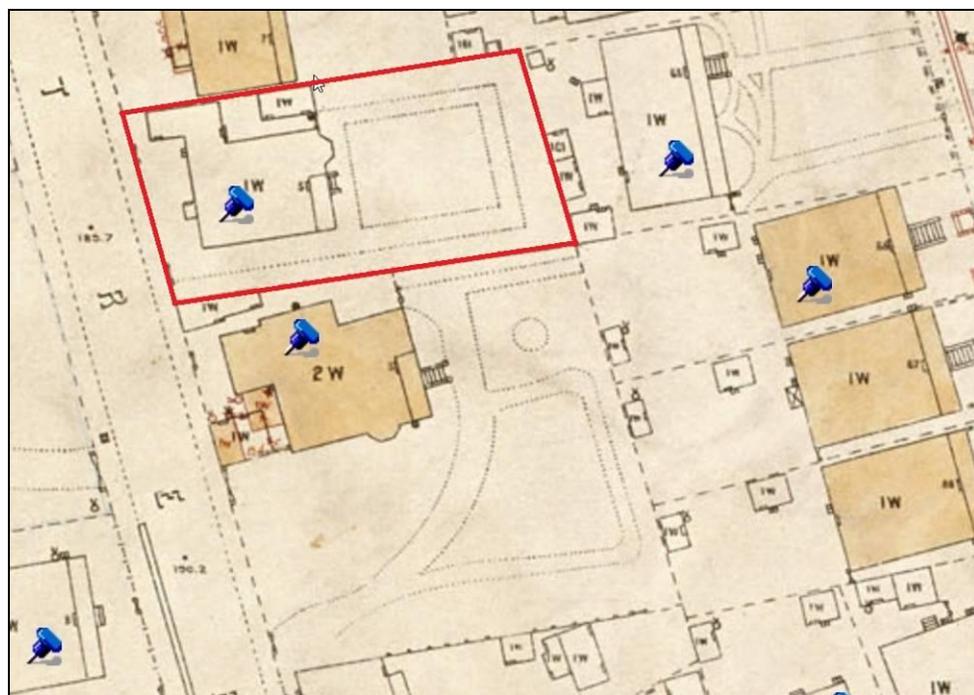
1908 Auckland Map - Number 7 Arthur Street outlined in red. Both it and number 5 (immediately south) face east.¹ Note also that the site at [what is now] number 3 was vacant, as part of the large land holding at number 5.

- 3.6 The 1908 Auckland map however shows what is very likely the same house – facing away from the street. The map actually shows a number of houses on Arthur Street facing east – in order we presume to face the city and the view, as the falling topography presented this opportunity. The extract from the map below shows the house adjacent at number 5, similarly facing east.

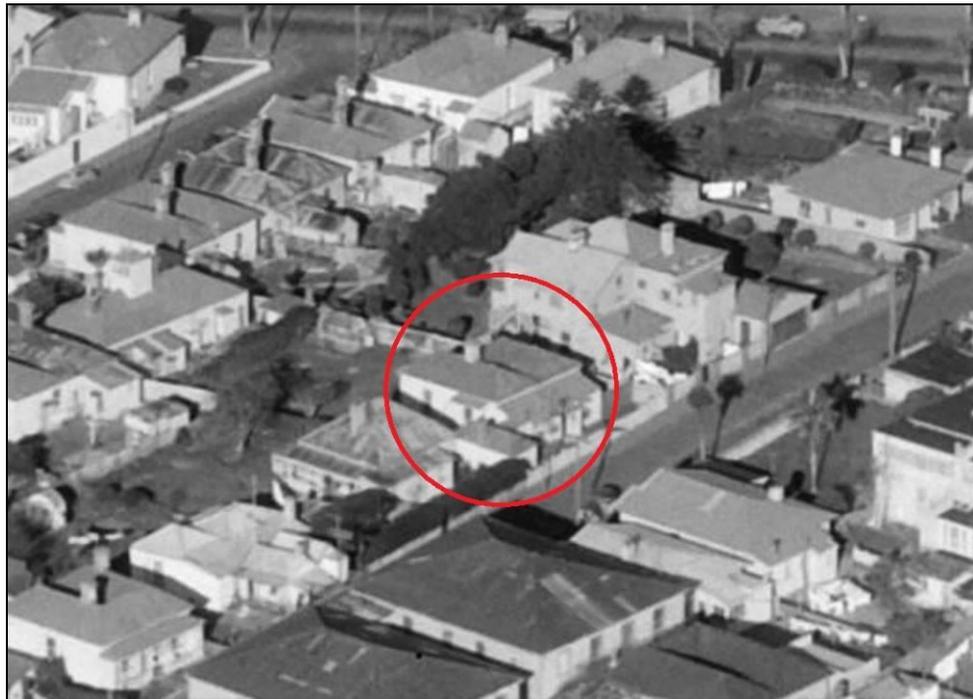
1955 - Number 7 Arthur Street circled in red. The house faces east. The lean-to facing the street is a typical component of the rear façades of early Auckland villas.²

- 3.7 Aerial photographs from the 1950s and later architectural plans seem to match the footprint shown in the 1908 map, although the records are not entirely conclusive about whether this was [and is] the original house – or at least one that dates pre 1908.

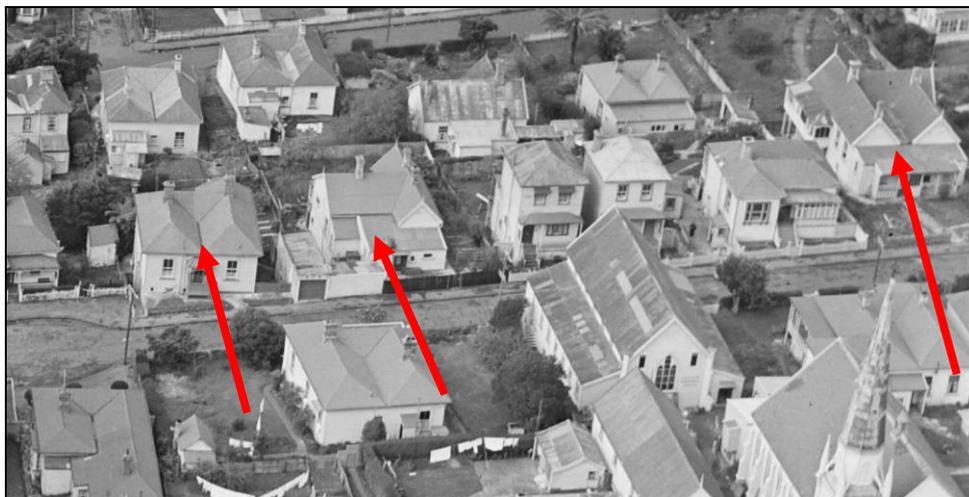
1949 – As examples of other buildings on Arthur Street that similarly face away from the street – From left to right, numbers 33, 31 and 23 all face east.³
