Appendix VII: Footpath rating specifications

Footpath condition is graded on the scale of 1 to 5.

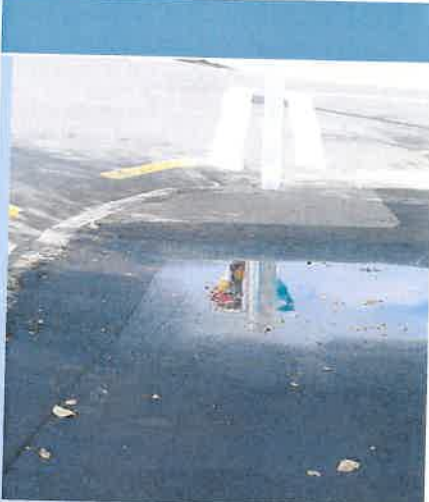
Grades	Grading description	Example photo
CG4	<p>hazard or dangerous; some weed infestation in joints.</p> <p>Poor condition</p> <p>Failure likely in short term; becoming dangerous with significant risk for health or safety of public. Asset unlikely to function without major repairs or replacement of asset within 1-2 year.</p> <p>Comments:</p> <p>Large cracks exceeding vertical and/or horizontal displacements of 10mm that could cause pedestrians to trip; bad ponding; unstable slabs; widespread infestation of weeds through joints.</p>
