Summary of Mediterranean fanworm (*Sabella spallanzanii*) surveillance at Great Barrier Island, April 2018

Surveillance outline

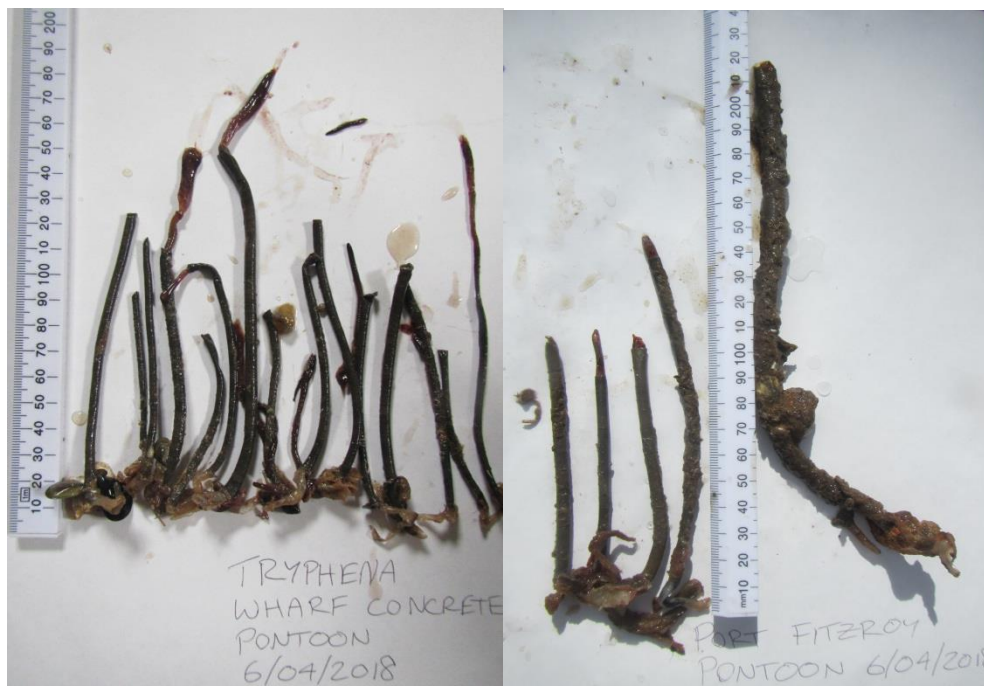
Port Fitzroy: Five Mediterranean fanworm were observed to be restricted to the pontoon at Port Fitzroy (Figure 1), as previously found in April during the initial response operations. During the previous December 2017 dive surveillance, Mediterranean fanworm was detected on the natural substrate in relatively close proximity to the pontoon. This area was searched with nothing found during the April 2018 monitoring.

Fifteen Mediterranean fanworm were detected on the relatively new concrete pontoon at the Tryphena wharf. This is within close proximity to where the one individual was detected within the natural soft sediment next to the wharf during the December 2017 dive surveillance.

Figure 1: Tryphena wharf & Port Fitzroy pontoon Mediterranean fanworm, April 2018.

All Mediterranean fanworm were measured, controlled and disposed of on land in an appropriate manner.
